Town Hall, Wallingford.

Two identified essential repairs now requiring attention.

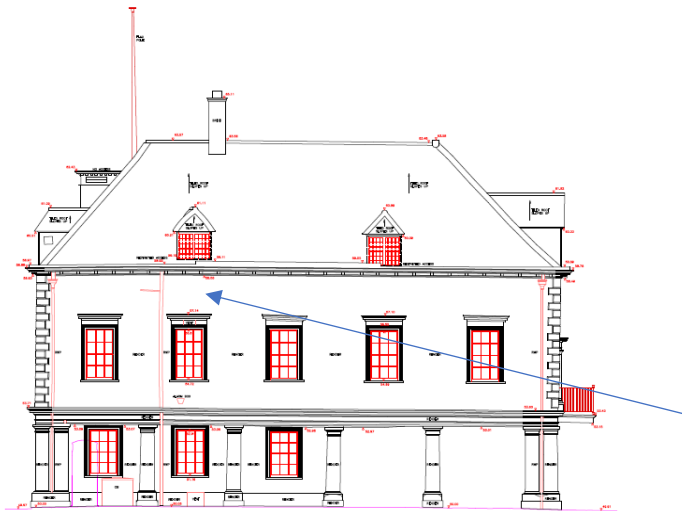
Cement based render. North East elevation.

This requires urgent attention. Cement render has lifted at high level and may have lost adhesion with expanded metal lathing.

2.09	North East nearest front elevation	Provision of safe working platform to gain safe access to failed cement render at high level.	4m2	Via safe working platform. Remove all failed and loose cement render. Remove back to sound base. To be advised any further treatment to timber works following inspection. Treat and re fix EML as required, prepare, seal and bond. Re render in lime based render. Specification to be provided. Make good to match existing colour decorations.	£ 4,000.00
------	------------------------------------	---	-----	--	------------

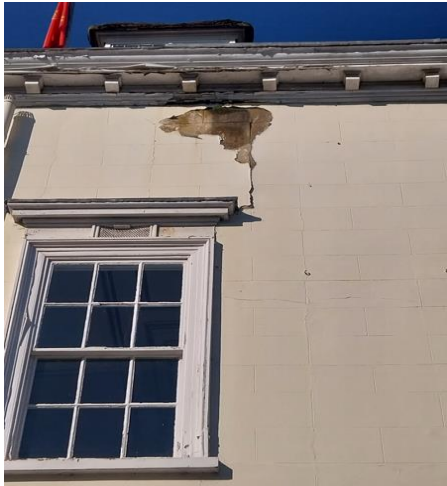
2024 photo. Note additional damage above render at timberwork.

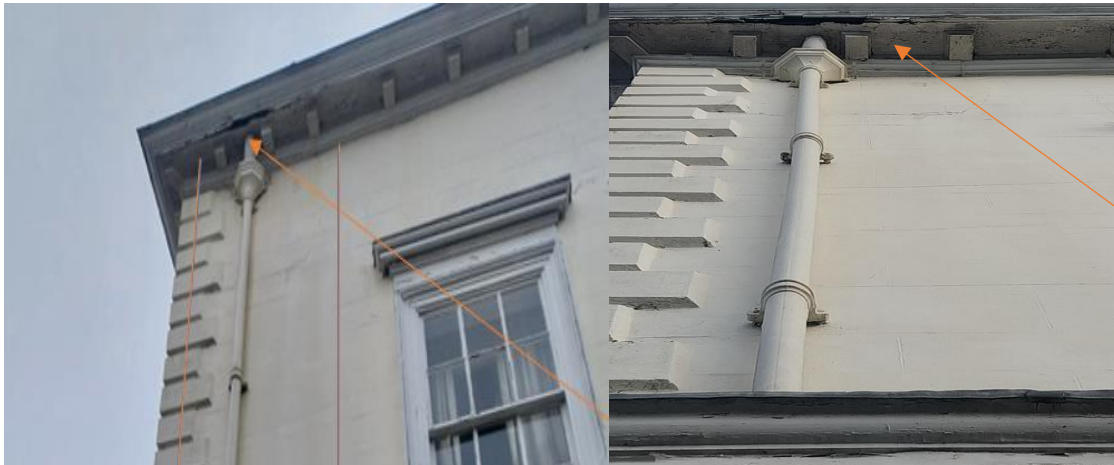
Rainwater Goods. North West elevation

Note the deterioration to the left and right above the hopper to the decorative cornice timber work. The rain water is not exiting by the hopper for whatever reason, possibly blockage from roof debris, expired bird, defunct birds nest?

2.04	North West (Old Post Office) elevation	Rainwater goods and associated.	1	Once RWG's have been overhauled to function as per manufacturers recommendations. Remove all noted corrosion, epoxy repair all cracked and failed metal works. Seal all joints, prepare and decorate as per to be provided specialists specification.	£ 1,200.00
------	--	---------------------------------	---	---	------------

2.01	North West (Old Post Office) elevation	Provision of safe working platform to gain safe access to Rainwater goods, hoppers and all associated items. Timber work, lead work etc.	1	Erect safe working platform to safely gain access to roof level to allow for inspection of parapet area, cornice timber work, to include, lead, gulley, outlet, hopper, down pipe connection etc.	£ 2,400.00
2.02	North West (Old Post Office) elevation	Rainwater goods and associated.	1	To safe working areas. Clean down all valleys, remove any debris from hoppers. Rainwater goods. Undertake quality control and check for correct water run off and dispersal.	£ 700.00

2.03	North West nearest front elevation	Decorative Timber cornice to high level North West elevation area of outlet/ hopper.	1no x. 2linear metres	Via safe working platform. Remove all failed and deteriorating timber. Remove all flaked paint. Splice in new seasoned treated timber as directed splicing to prepared timber as specification provided. Knot to all bare timber. Spot prime. Prime all new timber. 1no undercoat. 2no gloss exterior.	£ 1,800.00

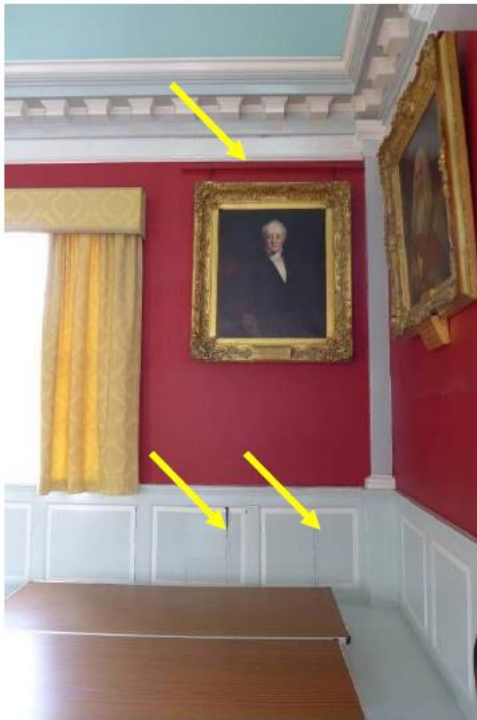
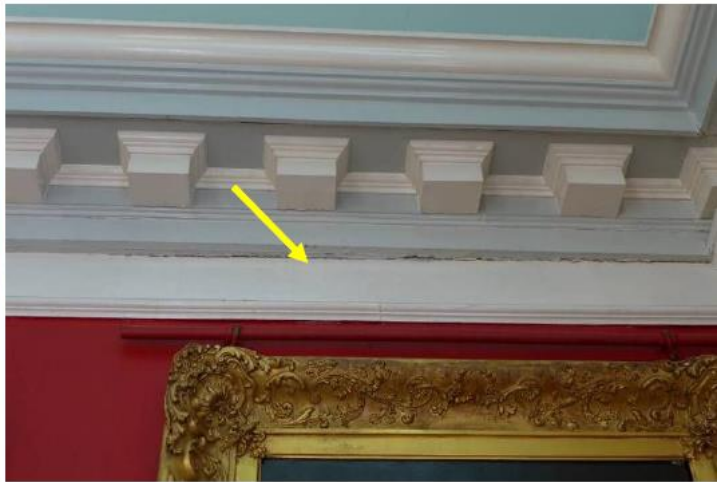
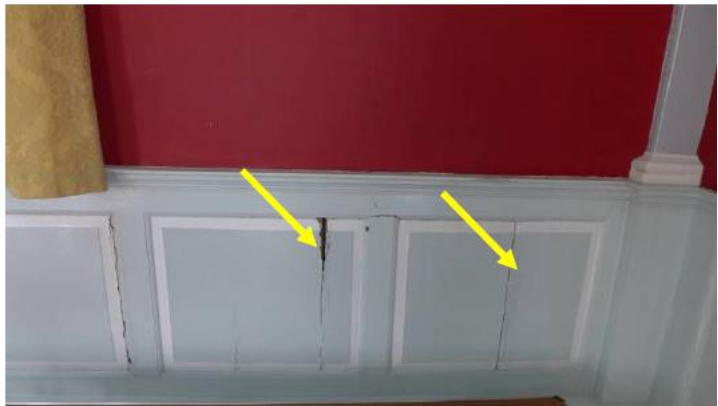
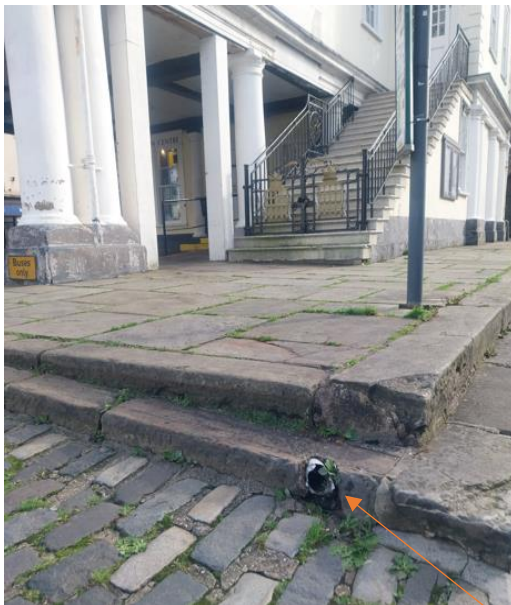
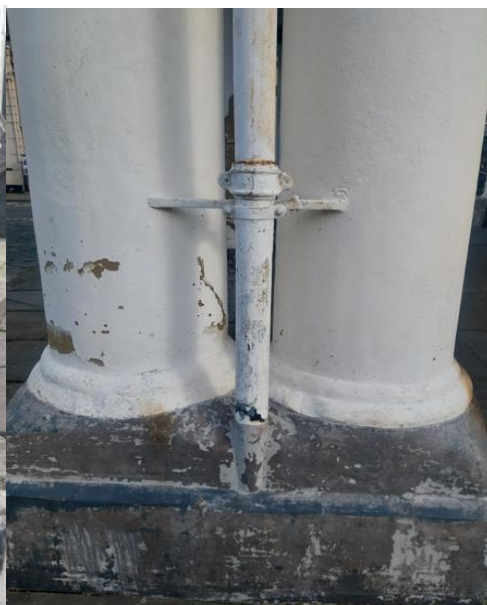
Water has been entering the building, The Main Chamber, first documented in **2015**. Please see later photo taken **2018**.

Water penetration to the ceiling and down the flagpole reflects poor external weathering.

Note outlet within kerb, which may or may not be related to the down pipe which is encased within the column plinth. No water escape noted at time of rain.

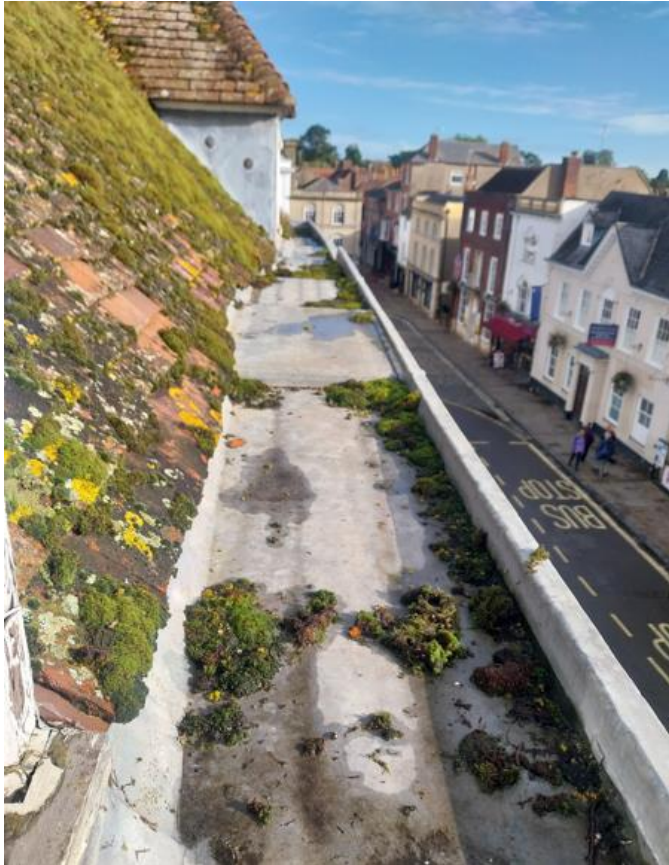
The North East elevation. Downpipe. Does have an open outlet at ground level. This is not discharging at ground level, rain water is visible discharging down the face of the building elevation. At present no water has been noted to be entering the building. Area shown suggests blocked valleys.

2.05	North East (Theatre side) elevation	Provision of safe working platform to gain safe access to Rainwater goods, hoppers and all associated items. Timber work, lead work etc.	1	Erect safe working platform to safely gain access to roof level to allow for inspection of parapet area, cornice timber work, to include, lead, gulley, outlet, hopper, down pipe connection etc.	£ 1,300.00

2.06	North East nearest front elevation	Rainwater goods and associated.	1	To safe working areas. Clean down all valleys, remove any debris from hoppers. Rainwater goods. Undertake quality control and check for correct water run off and dispersal.	£ 700.00

2.08	North East nearest front elevation	Rainwater goods and associated.	1	Once RWG's have been overhauled to function as per manufacturers recommendations. Remove all noted corrosion, epoxy repair all cracked and failed metal works. Seal all joints, prepare and decorate as per to be provided specialists specification.	£ 740.00

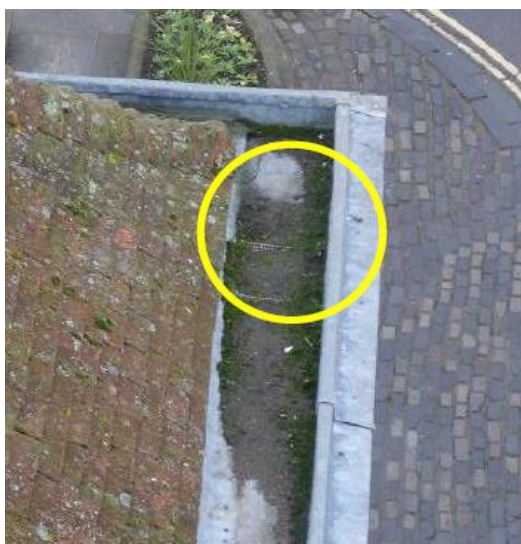
Note also below. Taken in 2018.

Outlet to hopper would appear to be blocked.
